Hereby an update 29 April 2019 of the long term trial as discussed.

In November 2017, your company has a \varnothing 80mm Stainless steel pipe supplied with an RZ-ECOSEAL layer.

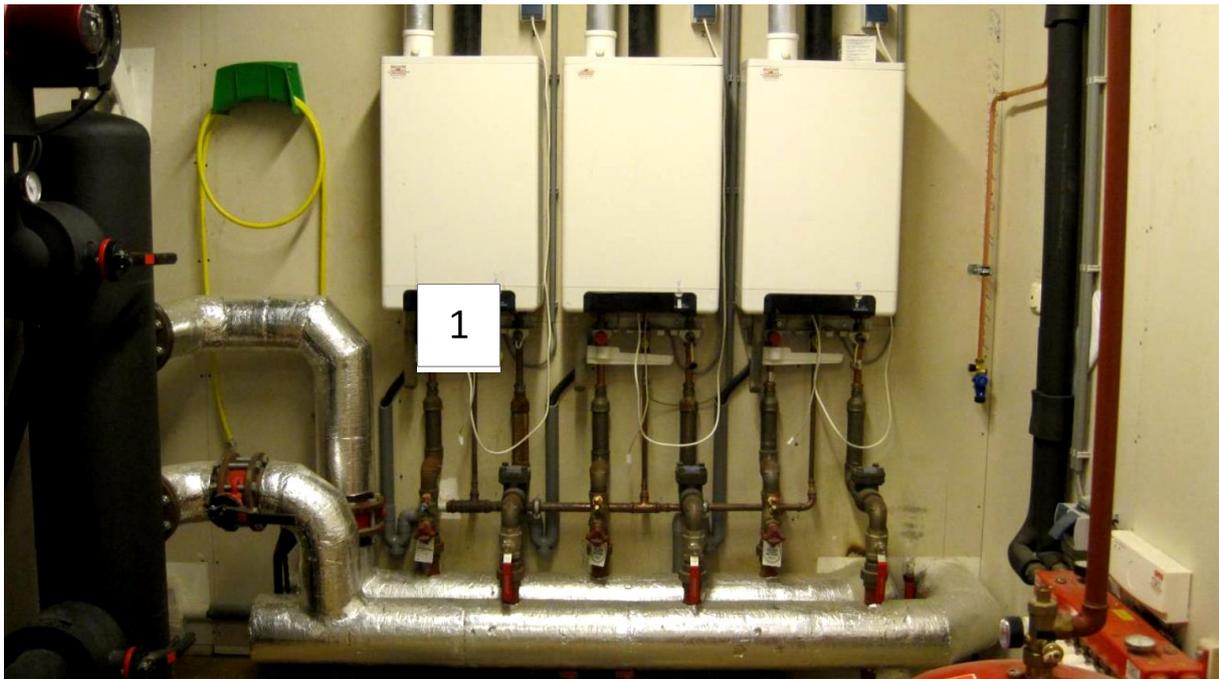
We have installed the part for the duration test in one of our exhibits at Intergas in Coevorden, see the pictures below (boiler 1).

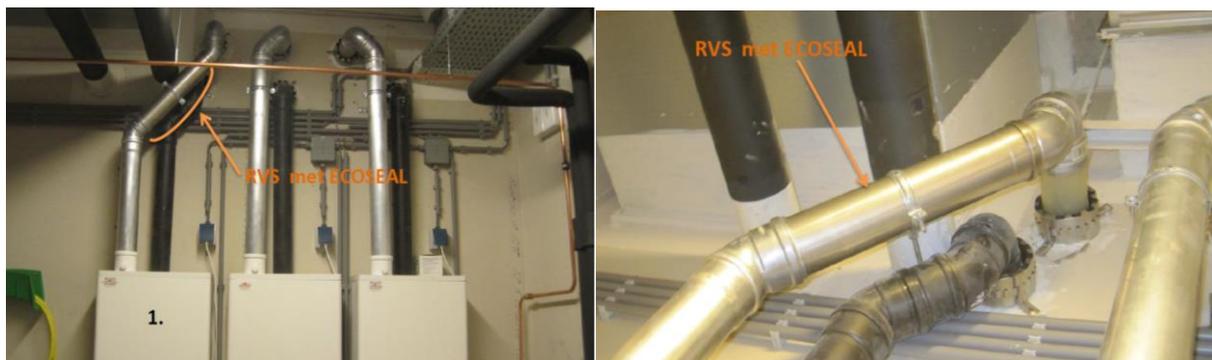
Boiler type Kombi-compact type: Solo HRE 40
Serial Number: 040397-1202501816 2012

Nom. Call top-up CV: Q = 8.6-47.1 KW
Nom. Bel undervalued CV: Q = 7.8-42.5 KW
Rated power 80/60: P = 40.9 KW
Set CV power: 99%
Set Gas type: G25

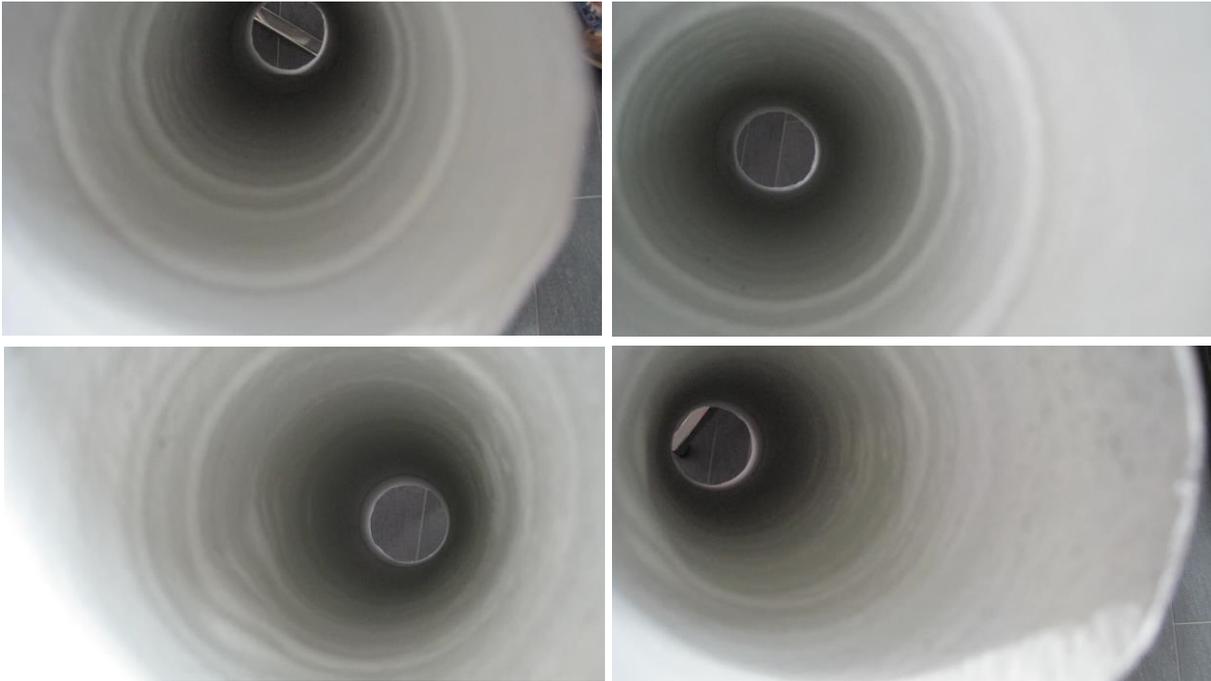
Photos Stainless steel flue gas exhaust pipe (with rz-ecoseal) as supplied by your company for comparison with regard to the endurance test.

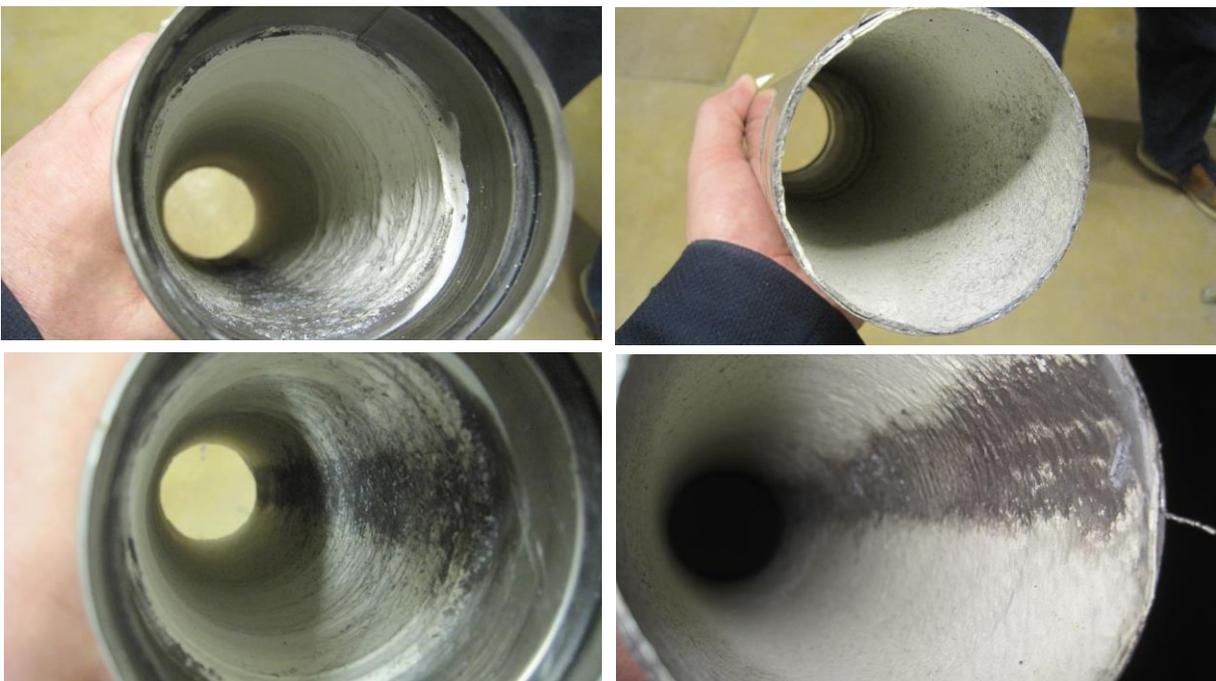
Photos Stainless steel flue gas discharge pipe (with rz-ecoseal) with a long term test that was carried out from 11-11-2017 to 21-3-2018, with 3158 operating hours of central heating.

On 21-3-2018 we disassembled the pipe and re-examined it again with the other unused part compared.

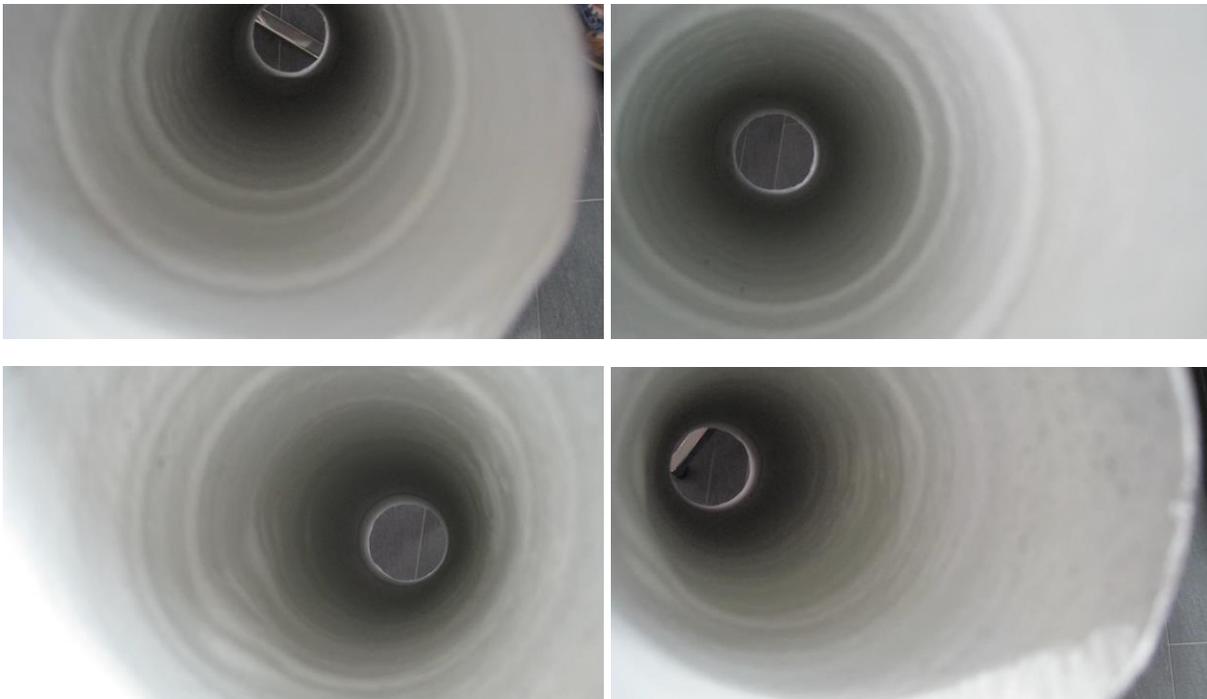
photos stainless steel flue gas exhaust pipe (with - coseal) as delivered in November 2017 for comparison with respect to the endurance test.

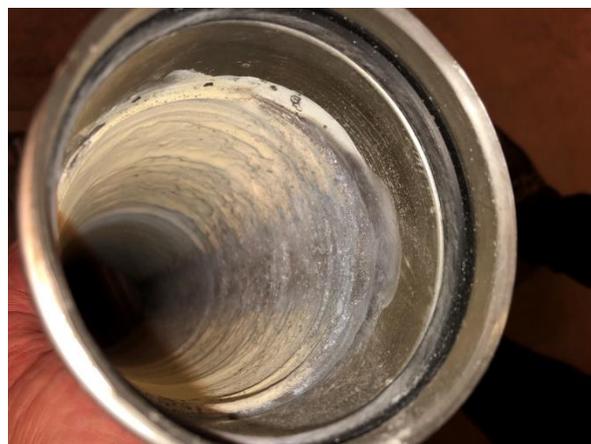
In total, this test has been 12768 hours in the set-up, the boiler concerned has run 7942 hours of operation (62.20 load) including the summer period

photos stainless steel flue gas discharge pipe (with rz-ecoseal) with an load test that was carried out from 1-11-2017 up to and including 16-4-2019, with 7942 operating hours.
